COMPOSITE UNIT ACCELERATED LIFE TEST  
OF THE HIGH GAIN ARRAY

Contract Number N00014-93-C-2021

January 28, 1992

Texas Research Institute Austin, Inc. (TRI/Austin)  
Reliability Engineering Division  
A.V. Bray, S.L. Arnett, and S.C. Liberty  
9063 Bee Caves Road  
Austin, Texas 78733  
(512) 263-2101

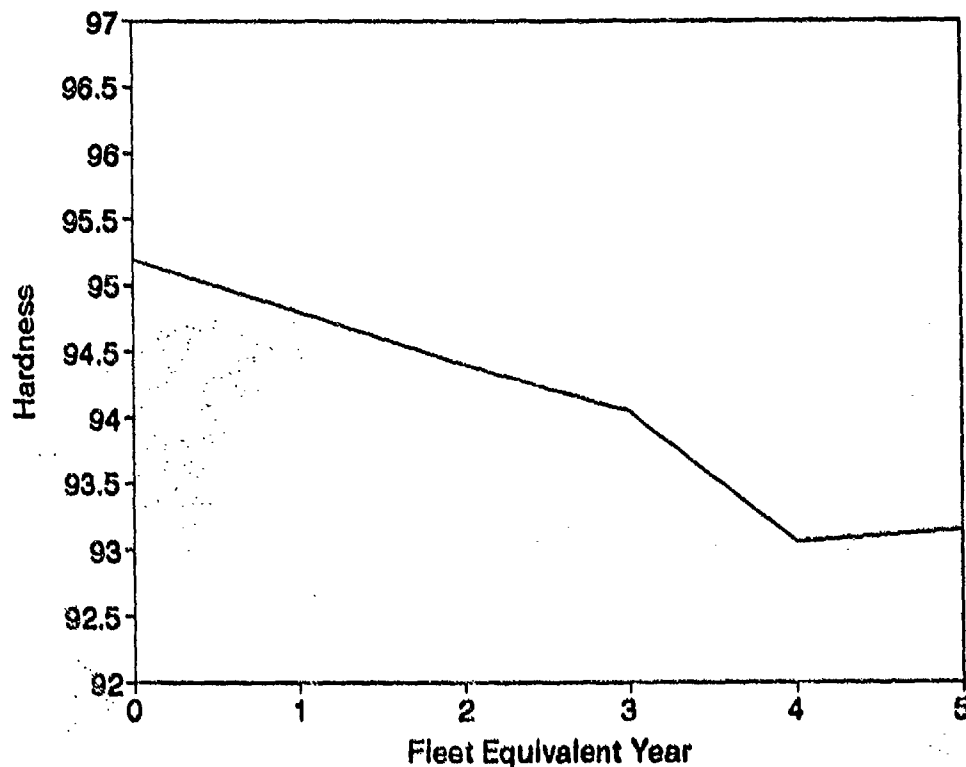
**Figure 6. Average Shore A Hardness for All Elements**

The Shore A hardness data, averaged over all elements, are shown in Figure 6. The polyurethane molding of the elements demonstrated a very high Shore A value which was not impacted by the ALT.

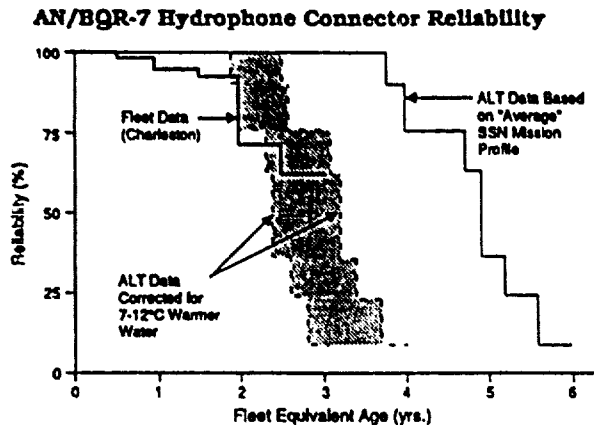
FIG. 2 A COMPARISON OF FLEET AND ALT RESULTS FOR THE MIL-C-24231 STANDARD CONNECTOR USED IN THE AN/BQR-7 SONAR

The ALT plan on which the laboratory tests were based was for an average submarine profile for units based in all ports [2]. The specific submarine used for the study was based in Charleston, S.C. in much warmer water than average. The primary failure mode for these connectors is cathodic delamination [4] of the polymer encapsulation material from the steel backshell of the connector, and this failure rate is accelerated by water temperature. The shaded region in Figure 2 shows the adjusted result had the ALT Plan been based on the warmer water exposure condition. This shows that the ALT scaling of the Fleet equivalent year was fairly accurate, and that ALT data are representative of the reliability of this connector in Fleet service. This connector has since been singled out for a higher reliability design which uses a glass reinforced epoxy composite backshell and eliminates the cathodic delamination failure mode [5].

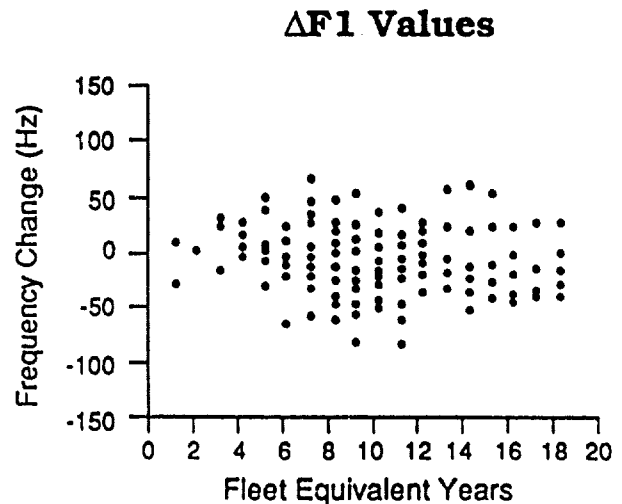
Admittance resonance-frequency change data from the test units are shown in Figure 3. The data are the result of a spectral features algorithm which fits the admittance and displacement per volt spectra with a cubic spline. The analytic function which results is then examined for extremes which correspond to resonance frequencies; and the quality factor ( $Q$ ) for each resonance is computed as the ratio of the 6 dB down peak width to the resonant frequency. These data are baseline corrected to their value in a new condition, i.e. for each measured spectral parameter the value  $C_i$ , where  $i$  is the time index, is referenced to time zero by

FIG. 3 BASELINE CORRECTED ADMITTANCE RESONANCE FREQUENCY MEASUREMENTS FOR THE TR-317R AS A FUNCTION OF FLEET AGE

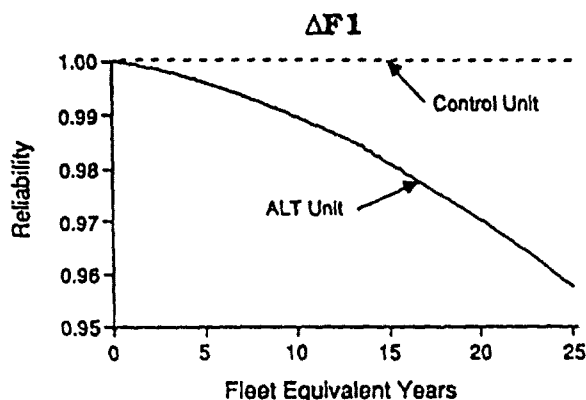
Figure 5 shows the reliability function associated with the data shown in Figure 3, and also includes the control unit reliability processed in the same manner. In

FIG. 5 THE RELIABILITY FUNCTION FOR THE DATA OF FIGURE 3 USING THE METHOD ILLUSTRATED IN FIGURE 4

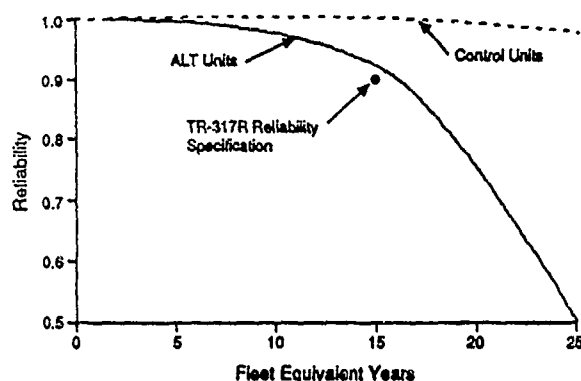
where the index  $j$  is over the individual reliability measures. There is admittedly an issue here regarding the independence of these estimates. Each  $R_j$  relates to a specified measure of degraded performance, but some may be degraded by the same failure/degradation mode as others. The impact of this effect is to provide a loose lower bound estimate of the reliability of the transducer. The resulting reliability estimate for the TR-317R transducer is shown in Figure 6 along with the control unit data processed in the same fashion. Also shown in the figure is the reliability specification criteria for this Fleet component, and from these data it is clear that the TR-317R satisfied the specification for reliability.

FIG. 6 FINAL ALT RELIABILITY ESTIMATE FOR THE TR-317R TRANSDUCER

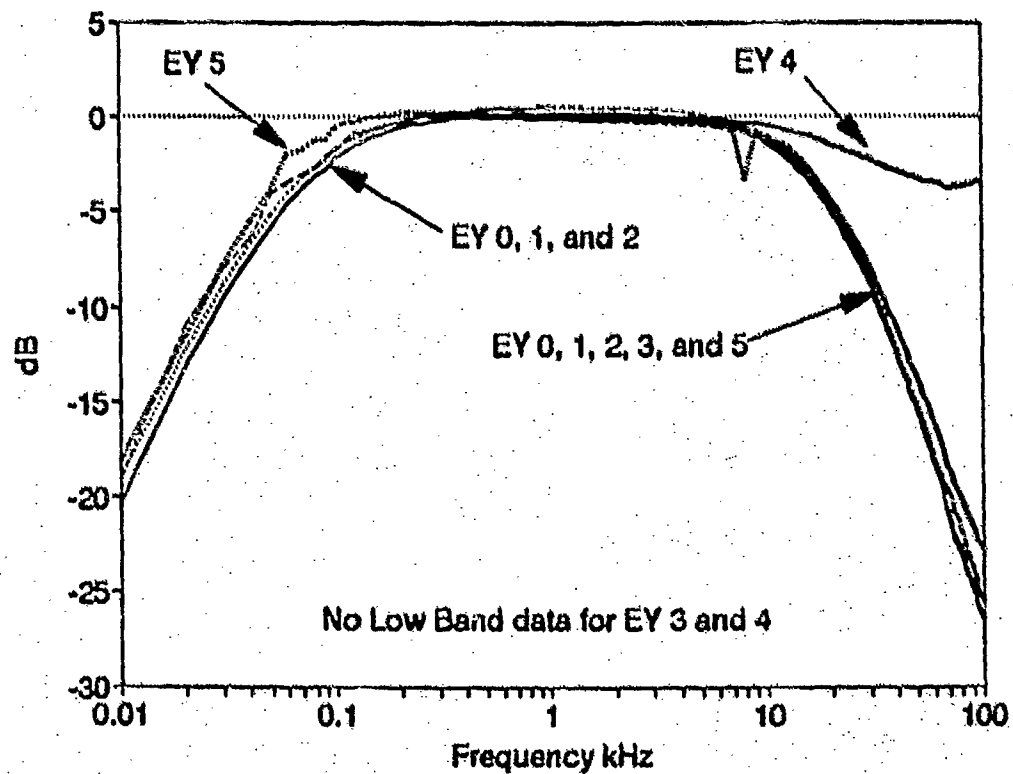
Element 10

Figure 4 is an example set of hydrophone gain response curves for element H2 of the HGA prototype stove. Note that there is little or no variation from one EY to another for this element. Figure 5 shows the same data for element H10, whose response appears to be erratic for the EY 4 measurement period. The roll-off of EY 4 changed dramatically from the baseline data of EY 0 but was back to normal in EY 5 - an indication that the hot air exposure prior to the EY 5 measurement removed from the unit the moisture that had evidently been a problem in EY 4. The response curves for all elements are included in Appendix C.

Due to these anomalies, elements H7, H10 and H15 are cause for concern.
